4. TITLE (and Subtitle) Phase I Dam Inspection Report National Dam Safety Program Newton County Structure F-1 (MO 20512) Newton County, Missouri		5. TYPE OF REPORT & PERIOD COVERED Final Report.

PHASE 1 INSPECTION REPORT  
NATIONAL DAM SAFETY PROGRAM  
STRUCTURE F-1 ID NO. 20512

SHEET 3A APPENDIX A  
 ANDERSON ENGINEERING, INC.  
 730 NORTH BENTON AVENUE  
 SPRINGFIELD, MISSOURI 65802  
 NEWTON COUNTY STRUCTURE F-1  
 MO. No. 20512  
SPILLWAY  
SECTION & PROFILE  
 NEWTON COUNTY, MO.

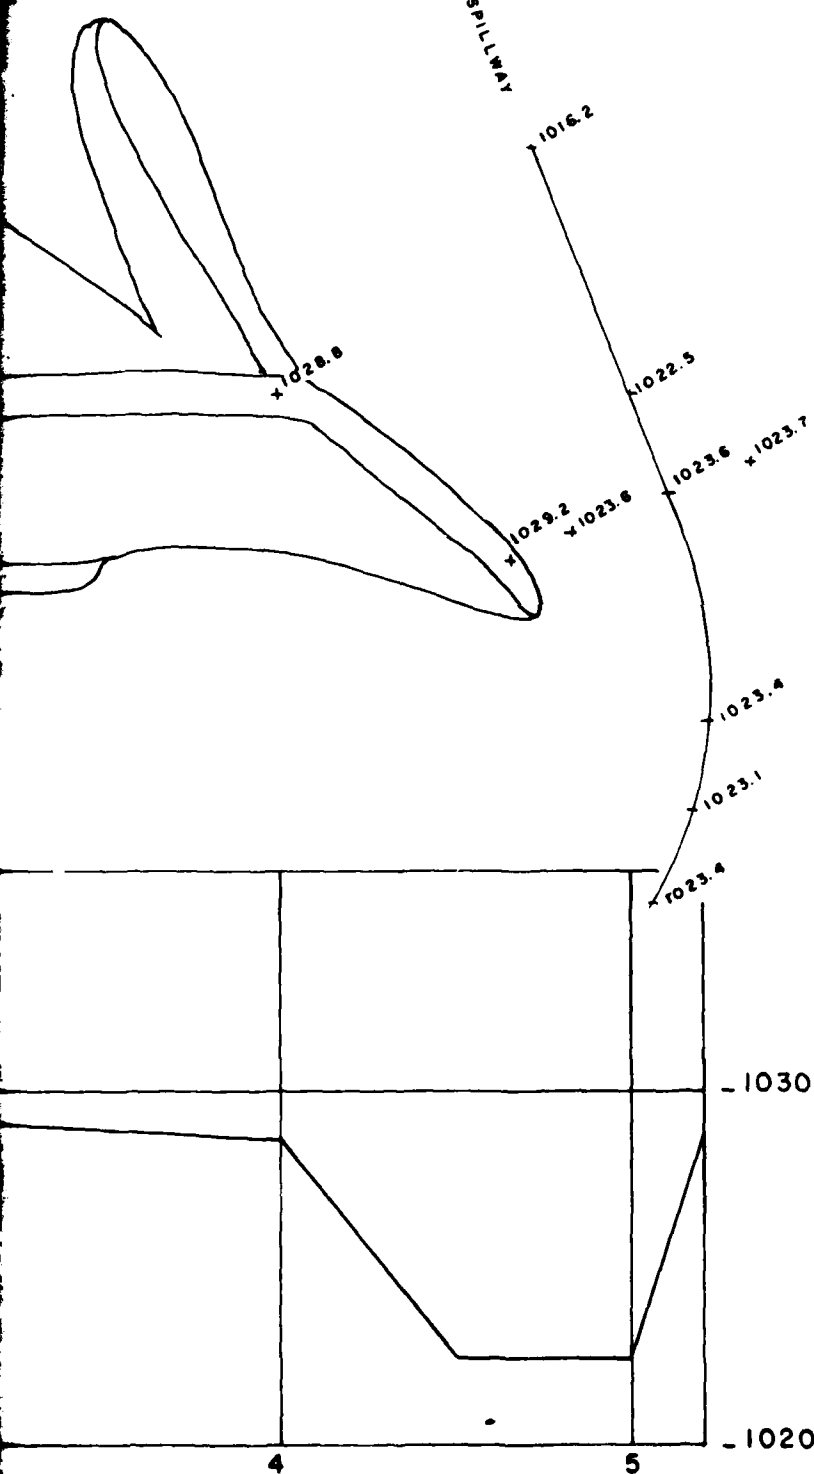
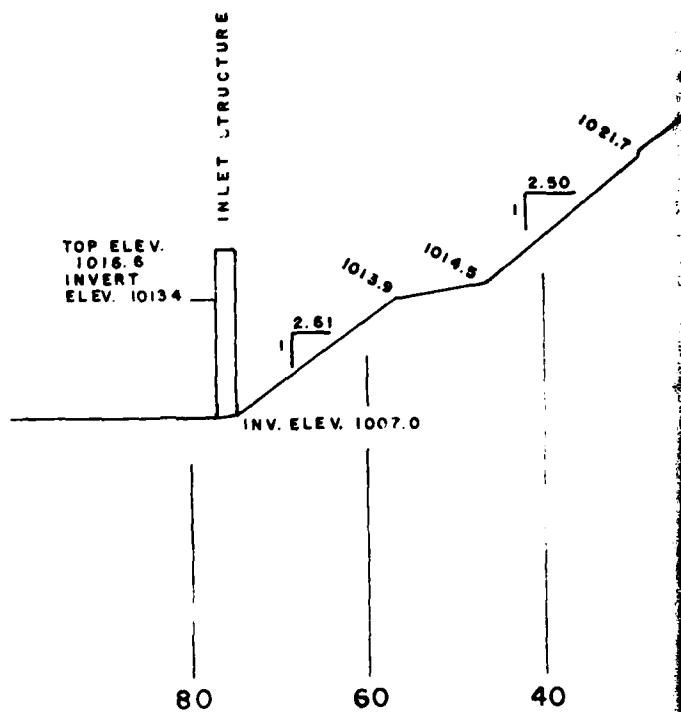
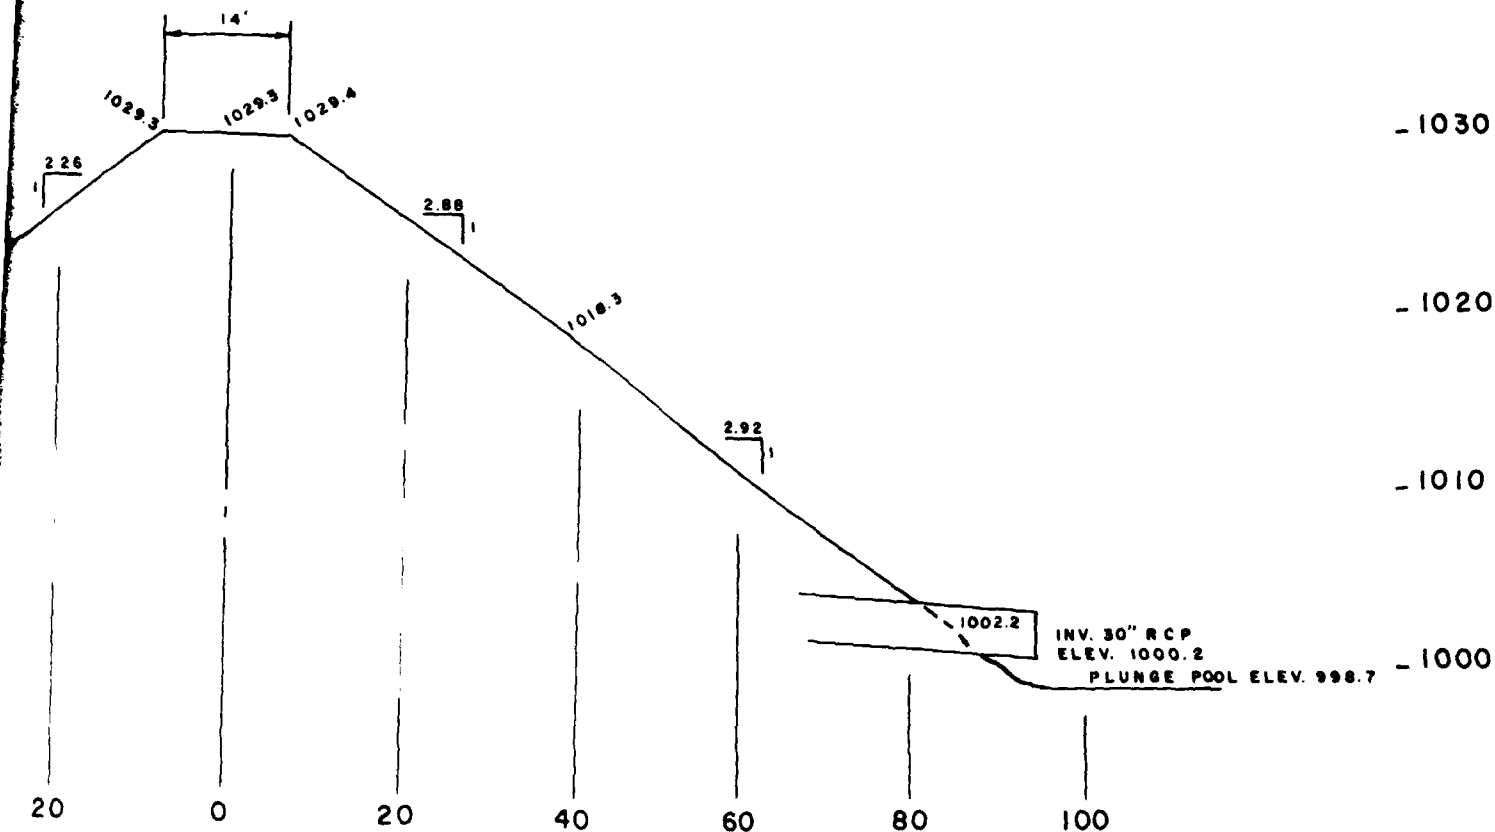
SHEET 3 APPENDIX A

PLAN & PROFILE

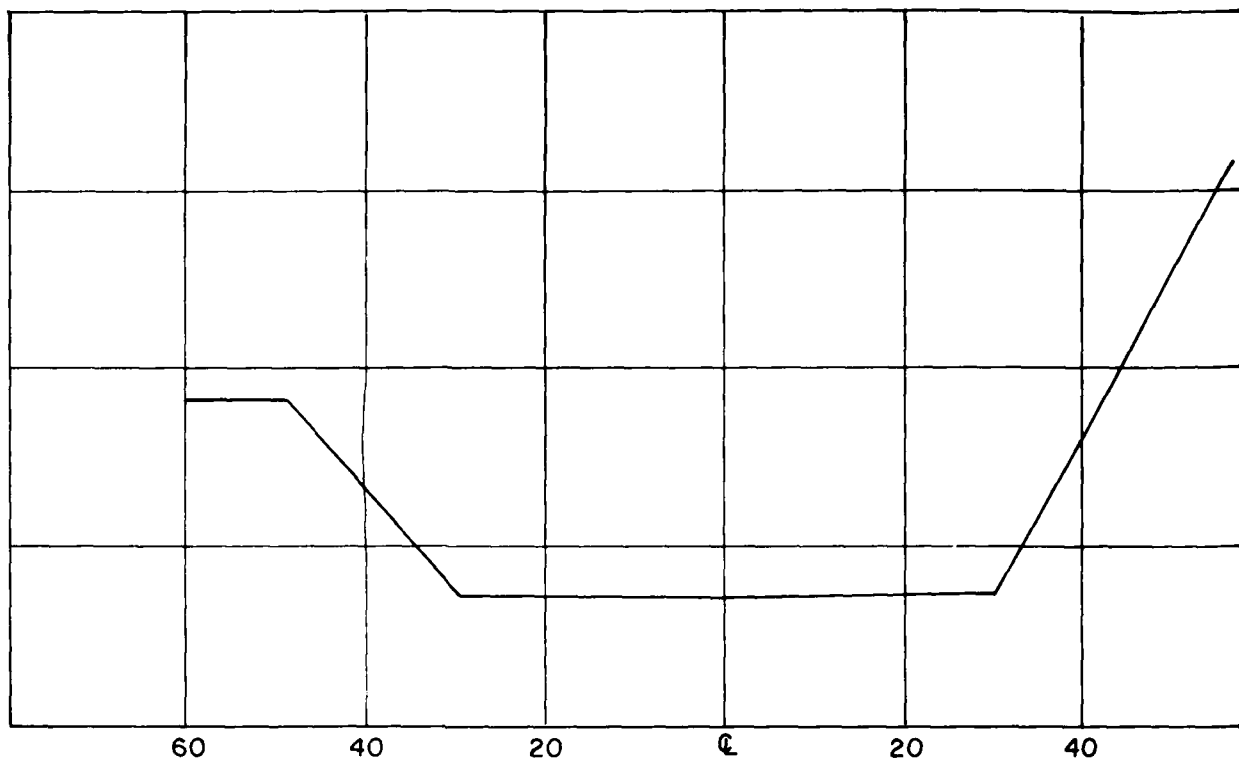
SPILLWAY SECTION  
30 FT. RIGHT  $\zeta$  DAM

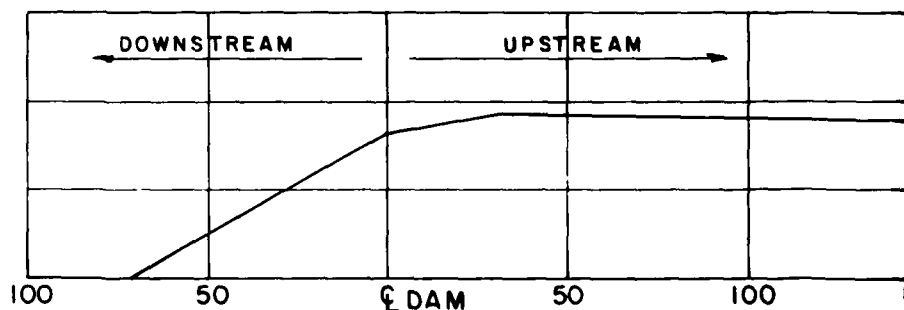
SPILLWAY PROFILE

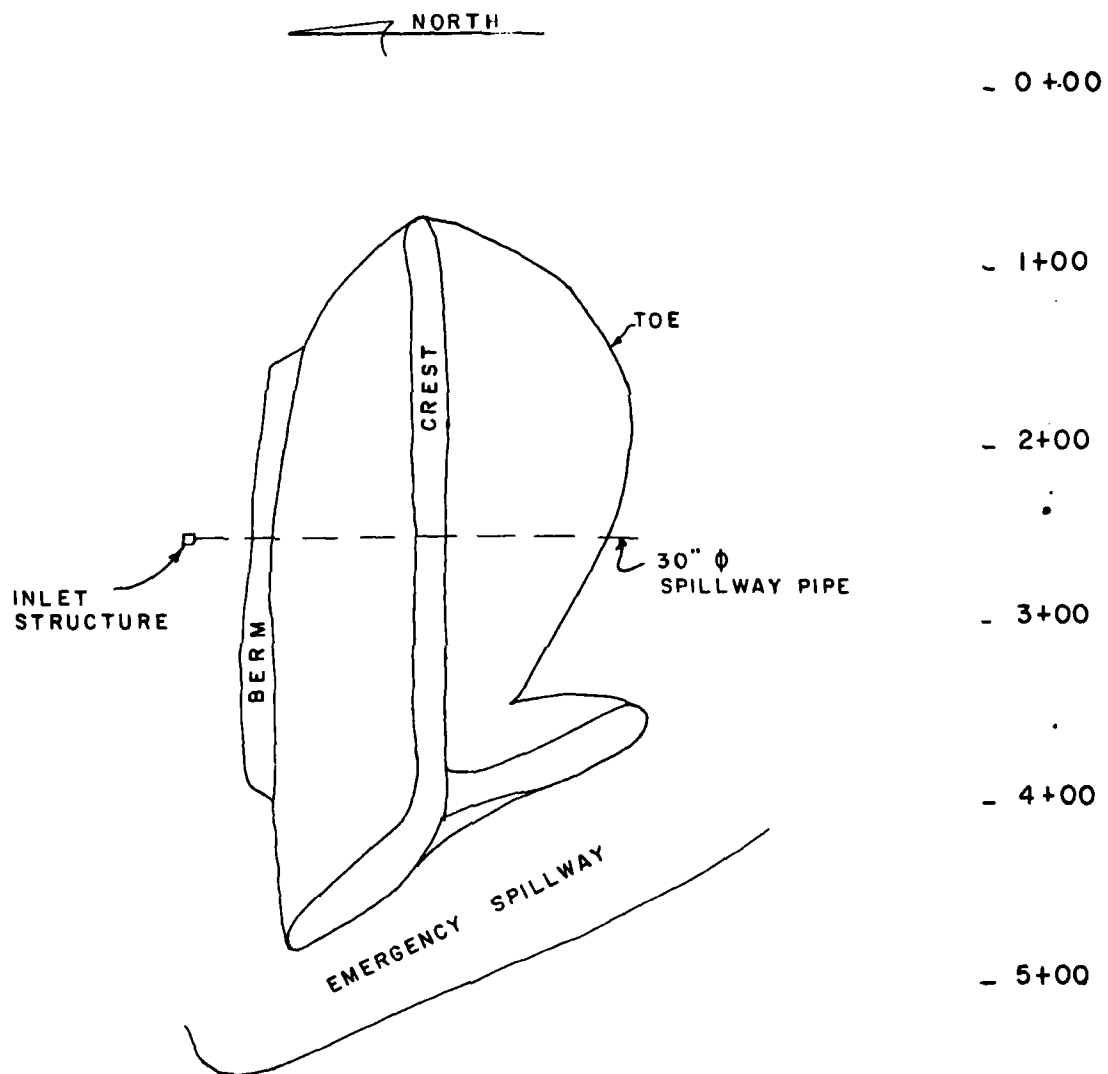
PLAN SKETCH OF DAM  
STRUCTURE F-1  
MO. No. 20512

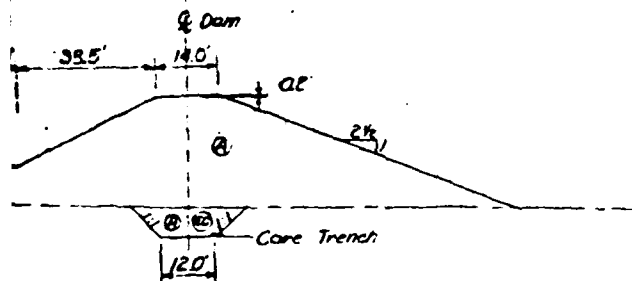
TYPICAL SECTION OF EMBANKMENT

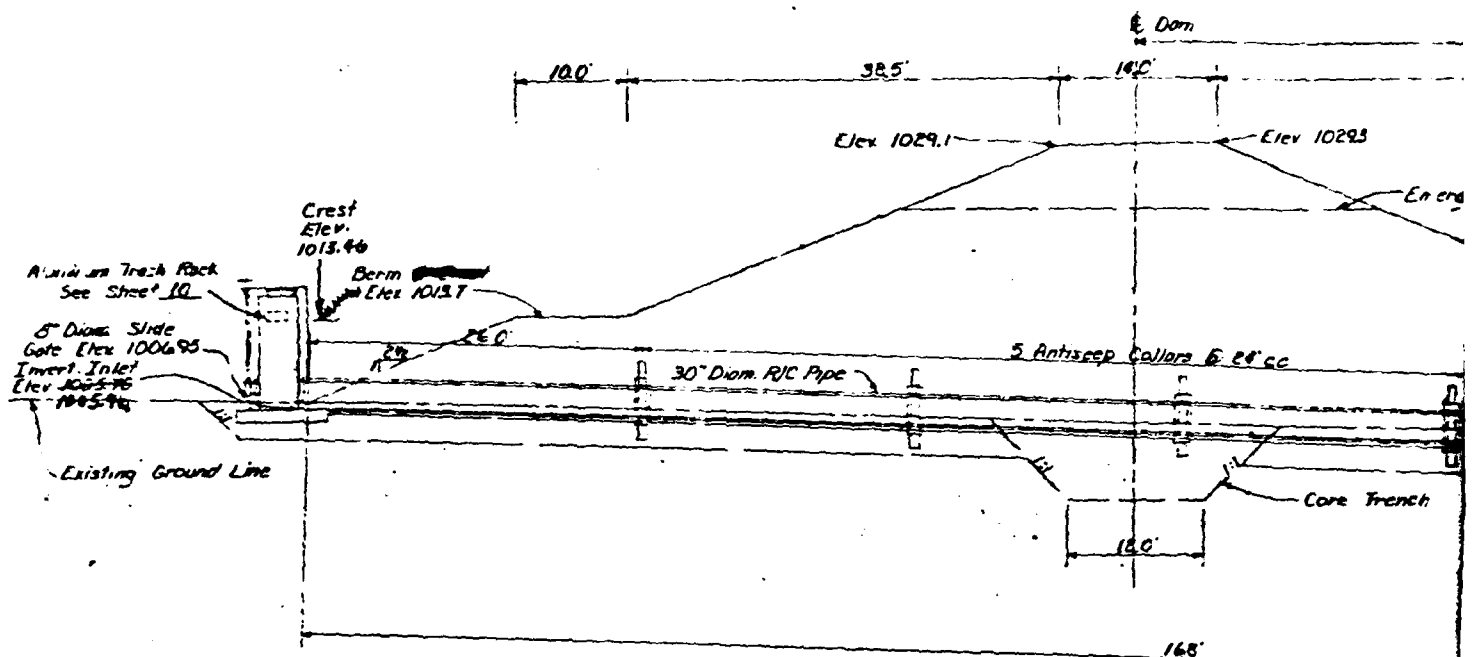
1. Antiseep collars shall not be placed closer than two (2) feet to a pipe joint.
2. Pipe elevations other than those shown will be furnished by the Engineer, when required.
3. Compacted backfill shall be placed over the riser footing up to the slide gate invert elevation. The backfill will be blended to the existing ground line as shown in the Riser Backfill Detail.

#### SECTION ON CENTERLINE

The principal spillway consisting of the 30 inch reinforced concrete spillway pipe and associated flow restrictor riser is in good condition. The 8 inch diameter slide gate was in good working condition.

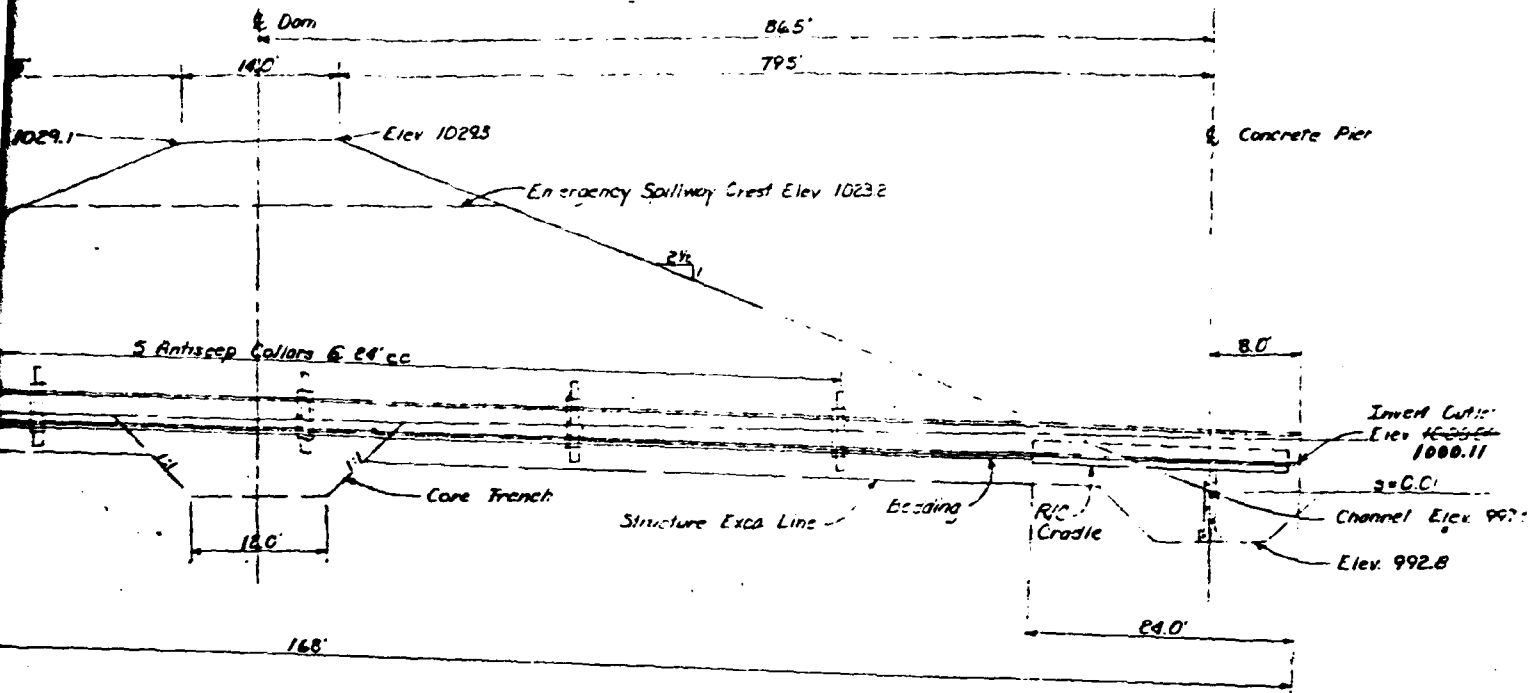
# SECTION ON CENTERLINE

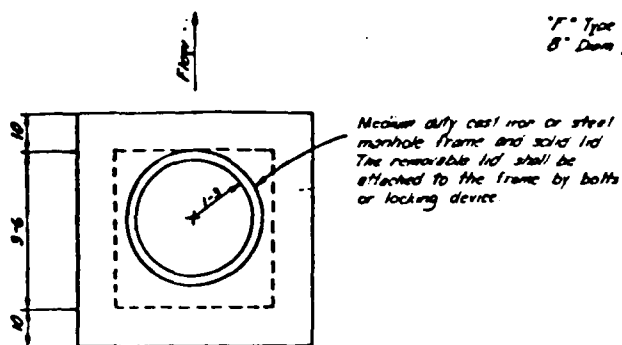
TOP PLAN

"F" Type Manhole  
8" Dia., 10" Long

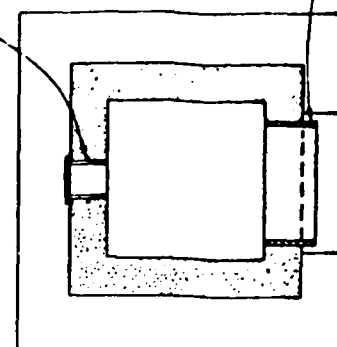
SECTION A-A

NOTE: FOR DETAIL OF TRASH BACK AND ANCHOR

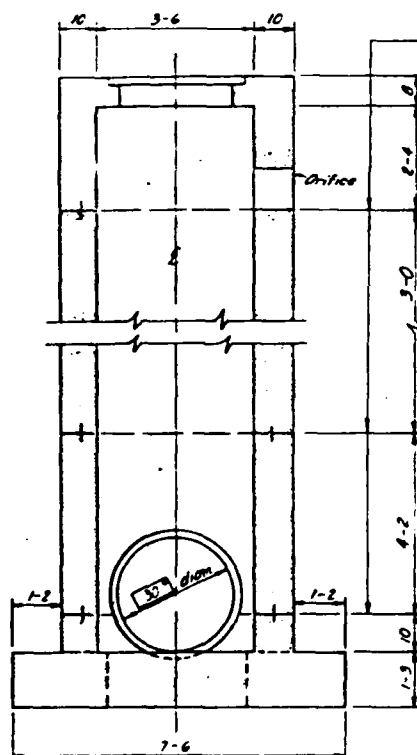
Shear plate construction joint,  
for detail see sheet 8

Removable Handwheel  
With Lift

8" Dia. Rising Stem  
Slide Gate

The maintenance required for the restricted flow riser is accomplished after the yearly inspection by the Watershed District Board. The slide gate appeared to be in good condition.

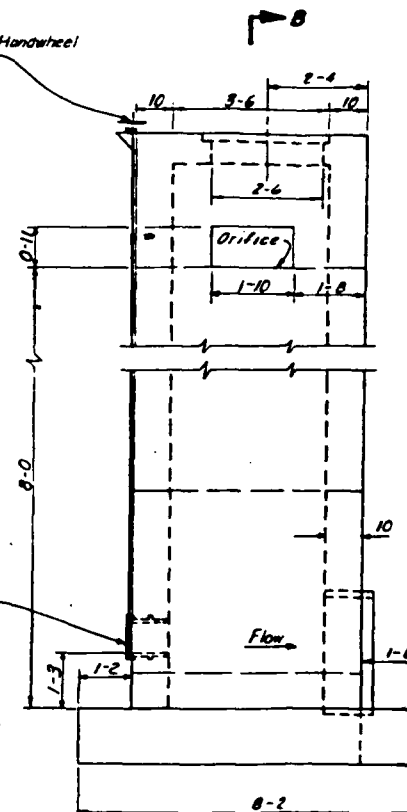
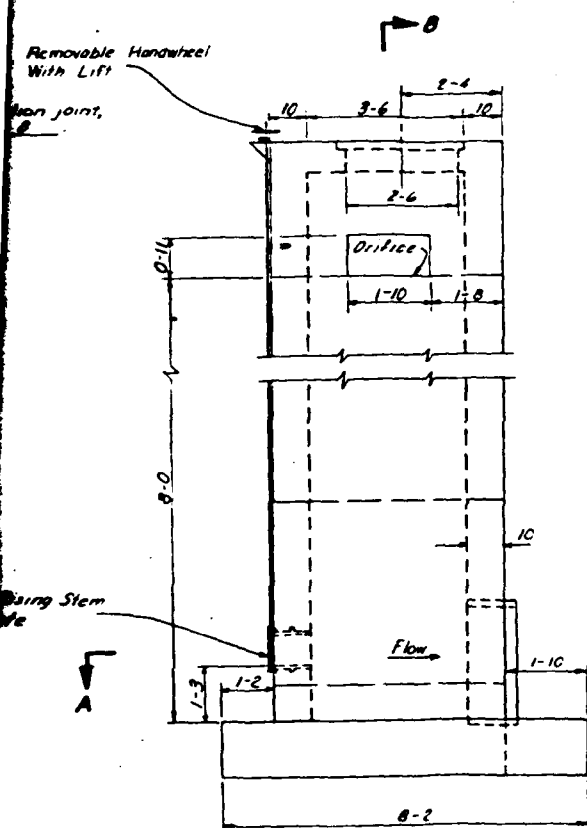
SIDEWALL ELEVATION

**DETAILS OF 3'-6" x 3'-6" SECTION B-B  
RESTRICTED FLOW RISER**  
(10' High Sewerall Orifice)

### SIDEWALL ELEVATION

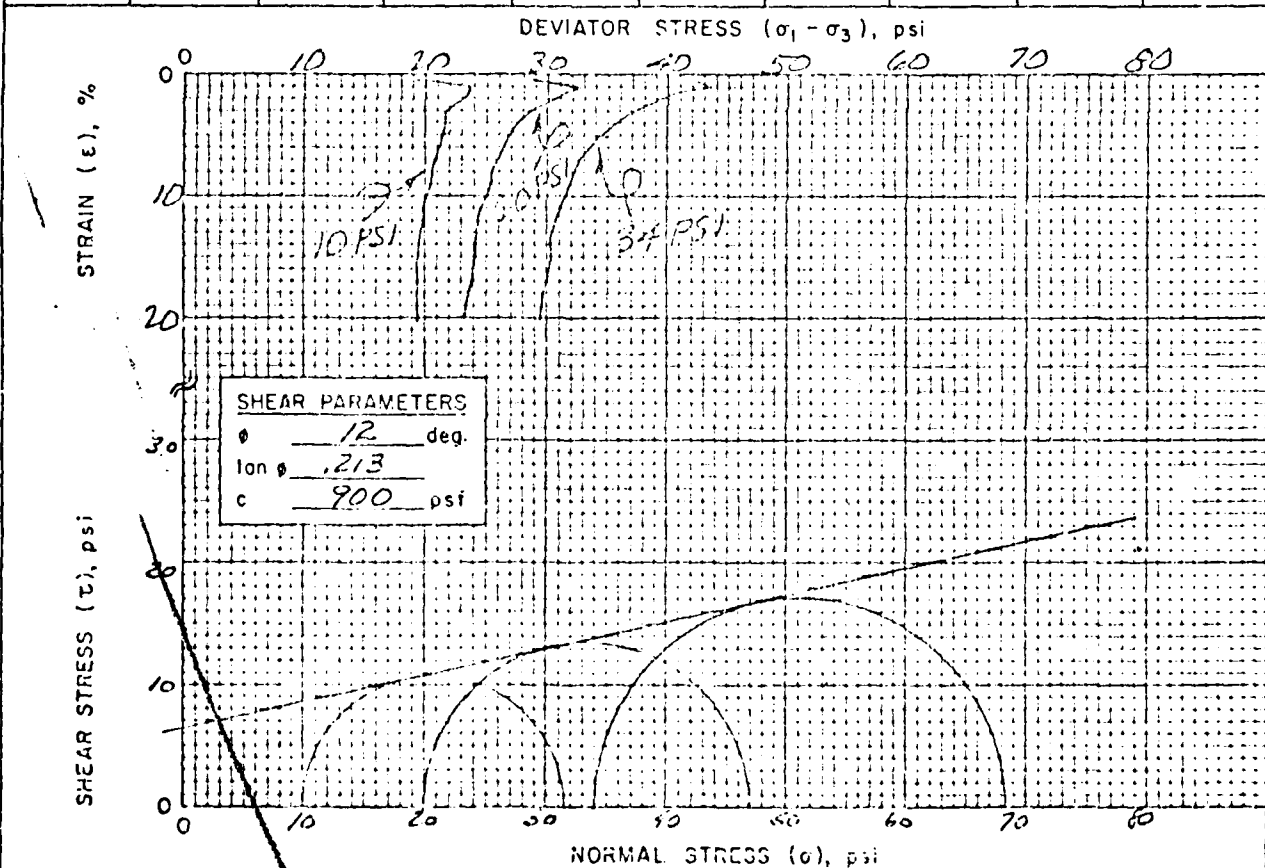
REMARKS BACK-PRESSURED

<b>MATERIALS</b>	U.S. DEPARTMENT of AGRICULTURE SOIL CONSERVATION SERVICE	<b>TRIAXIAL SHEAR TEST</b> with pore pressure measured
------------------	---	---

PROJECT and STATE <b>LOST CREEK SITE: F-1 MISSOURI</b>	SAMPLE LOCATION <b>Section 8 3+00</b>
TYPE OF SAMPLE <b>COMPACTED</b>	TESTED AT <b>SML LINCOLN</b>
APPROVED BY _____	
DATE _____

MINOR PRINCIPAL STRESS, $\sigma_3$ (psi)	PORE PRESSURE, $u$ (psi)	EFFECTIVE MINOR PRINCIPAL STRESS, $\bar{\sigma}_3$ (psi)	DEVIATOR STRESS, $\sigma_1 - \sigma_3$ (psi)	FAILURE CRITERIA	AXIAL STRAIN AT FAILURE, $\epsilon$ (%)
10	2.2	7.8	21.4		5.0
20	11.9	8.1	26.8		5.0
34	24.3	9.7	34.2		5.0

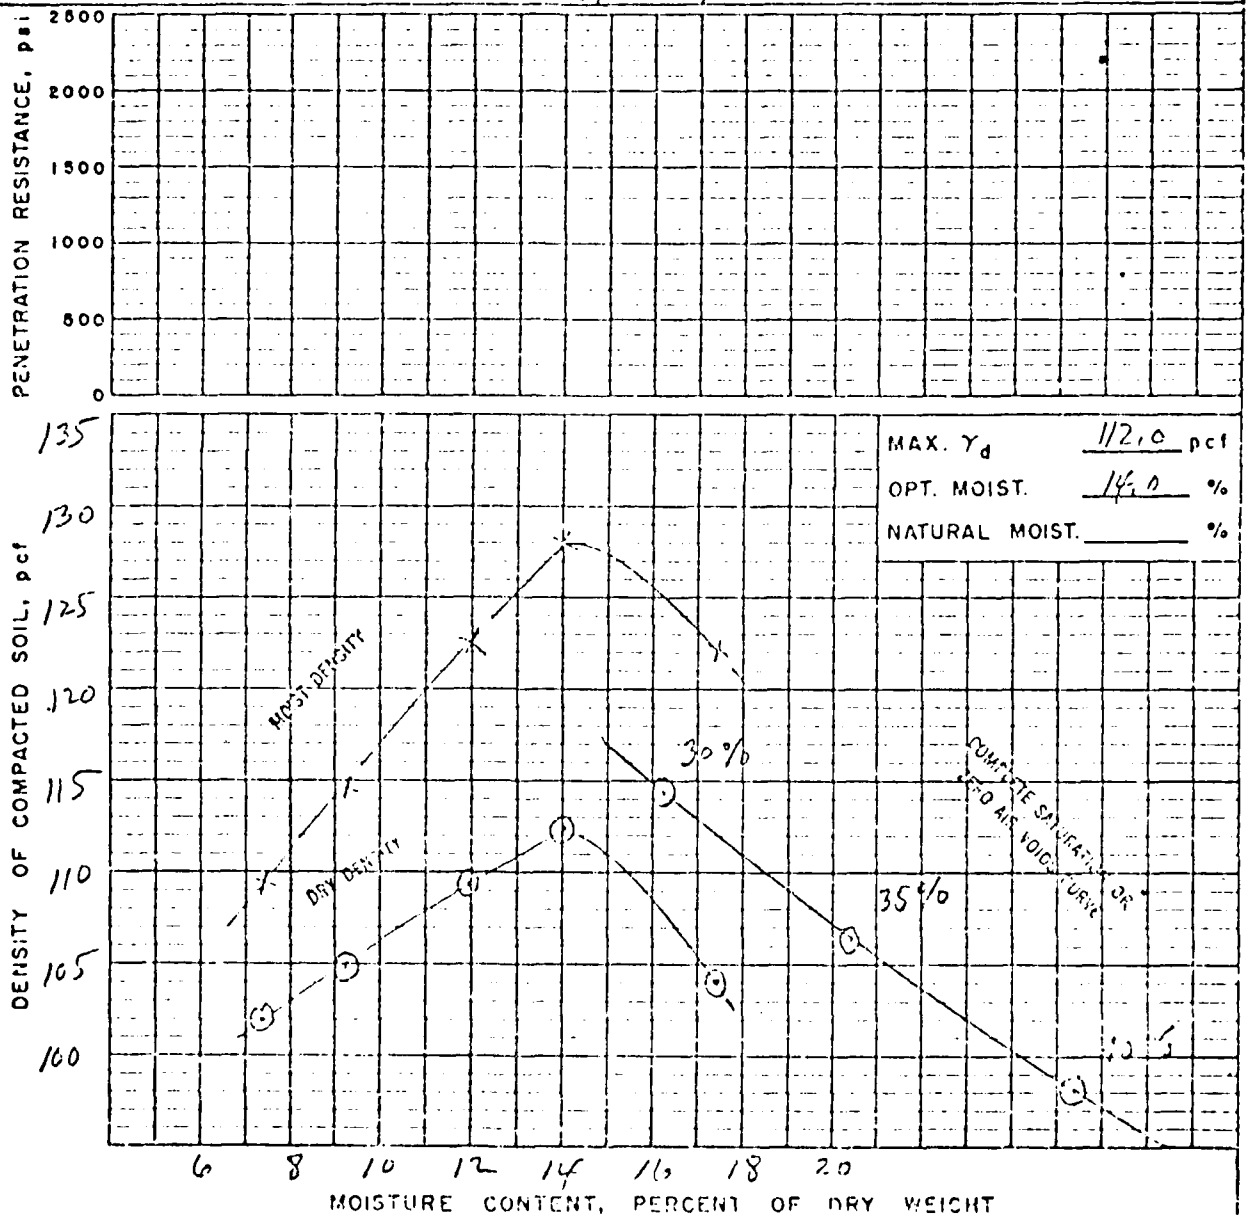
MATERIALS		U. S. DEPARTMENT OF AGRICULTURE		COMPACTION AND	
TESTING REPORT		SOIL CONSERVATION SERVICE		PENETRATION RESISTANCE	
PROJECT and STATE Lost Creek # F-1, Missouri					
FIELD SAMPLE NO. 103-1		LOCATION Borrow, B 3+00			DEPTH 2-6'
GEOLOGIC ORIGIN		TESTED AT SML-LINCOLN		APPROVED BY	DATE
CLASSIFICATION SC LL 35 PI 15		CURVE NO. 2X OF 2			
MAX. PARTICLE SIZE INCLUDED IN TEST 1.3		STD. (ASTM D-698) <input checked="" type="checkbox"/> ; METHOD C			
SPECIFIC GRAVITY (G <sub>s</sub> )		MOD. (ASTM D-1557) <input type="checkbox"/> ; METHOD			
MINUS NO. 4 2.65		OTHER TEST <input type="checkbox"/> (SEE REMARKS)			
PLUS NO. 4 2.48					
AV. 2.56

CURVE IS FOR THE MINUS NO. 4 FRACTION

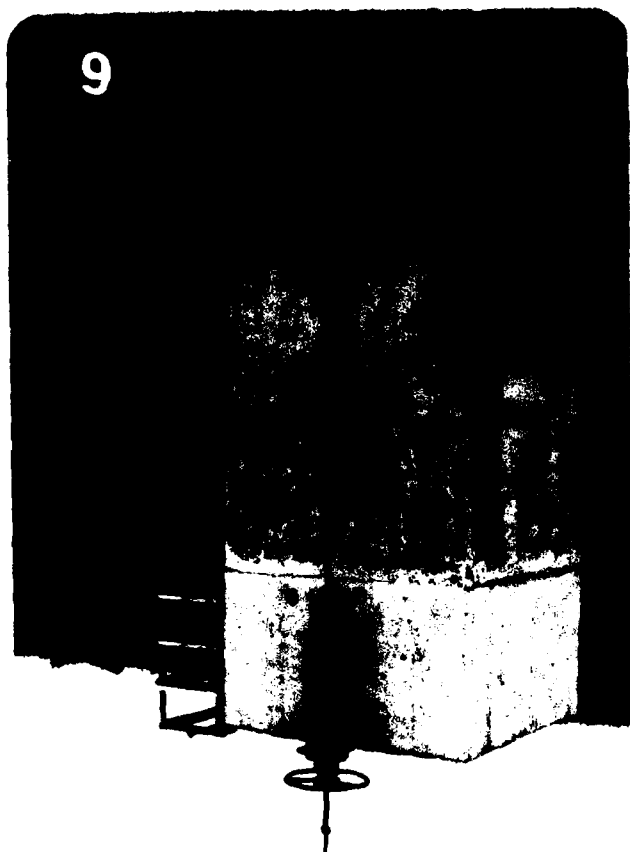
<u>Photo No.</u>	<u>Description</u>
1	Aerial View of Dam
2	Aerial View of Dam
3	View of Crest (Looking East)
4	View of Crest (Looking West)
5	View Upstream from Crest (Looking North)
6	View of Inlet Structure (Looking South)
7	Closeup of Inlet Structure (Looking South)
8	View of Spillway Outlet (Looking Northwest)
9	Upstream View of Emergency Spillway (Looking North)
10	Downstream View of Emergency Spillway (Looking South)
11	Downstream View from Crest of Dam (Looking South)
12	View of Upstream Face of Embankment (Looking Southeast)
